### **Site Investigation Report**

Range 30, Confidence Course (Firing Line), Parcel 88Q
Former Rifle/Machine Gun Range, Parcel 102Q
Former Grenade Range/Area, Parcel 106Q-X
Tank Sub-Caliber/Carbine Transition/Machine Gun Range (OA-08)
Grenade Court (OA-15)
Unnamed Small Arms Range

# Fort McClellan Calhoun County, Alabama

October 2006

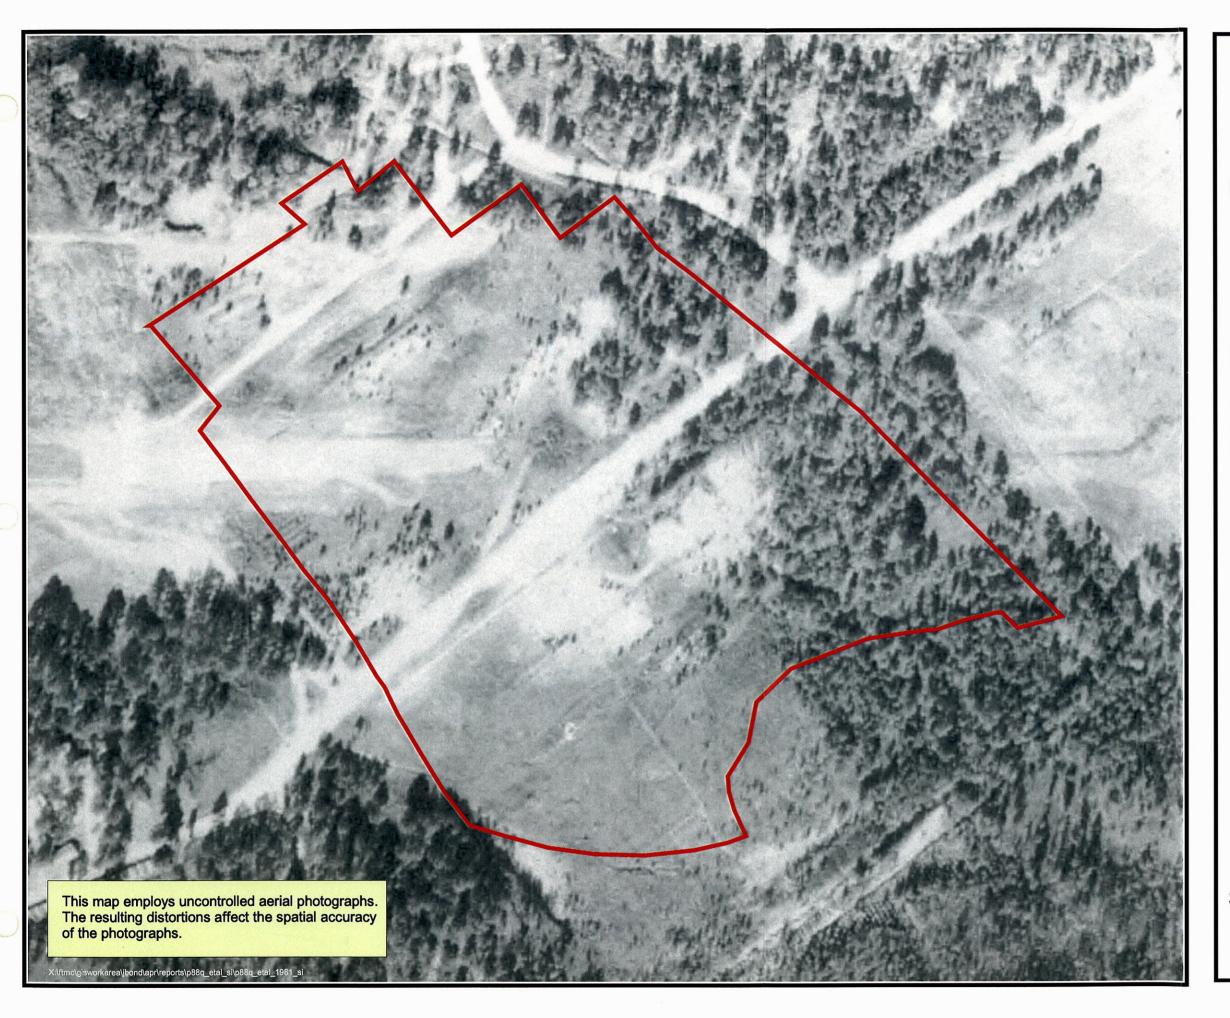
# Figure 1-5

- 22 **1961.** The 1961 aerial photograph (Figure 1-5) shows an increase in vegetative cover across the
- area of investigation, suggesting a decrease in activity between 1954 and 1961. In addition, the
- 24 photograph shows that clearing for Reilly Airfield had extended into the area of investigation,
- 25 although no paved runway extensions are present. The circular feature noted on the 1954 aerial
- 26 photograph is not present in this aerial photograph. However, the berms noted in the 1954 aerial
- 27 photograph are still present.

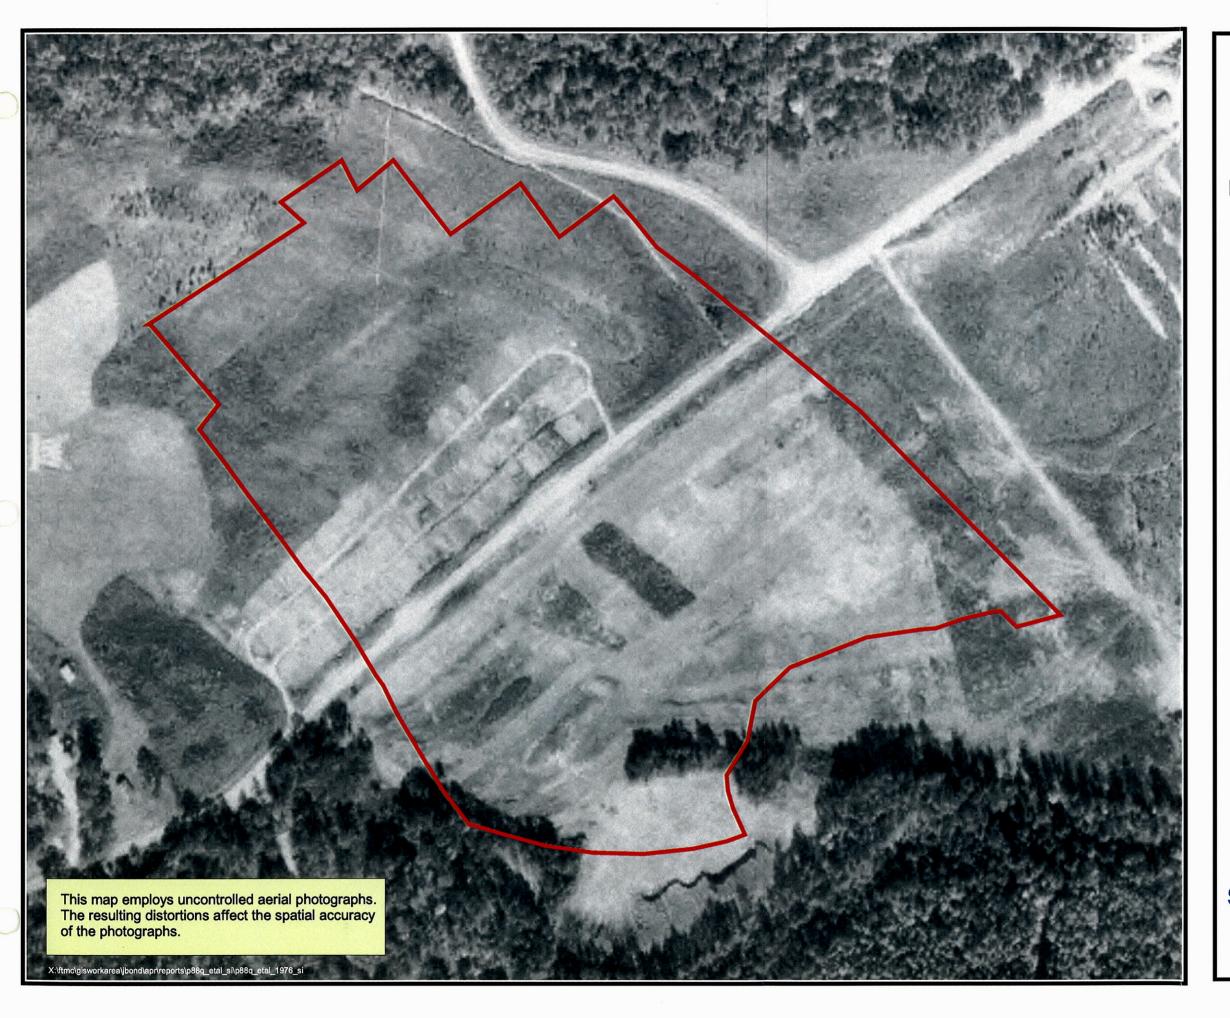
# Figure 1-6

1976. The 1976 aerial photograph (Figure 1-6) shows a new area of activity along the southern
 portion of the area of investigation. In this area, the vegetation has been cleared, and two roads
 and a berm have been constructed parallel to Falcon Road.

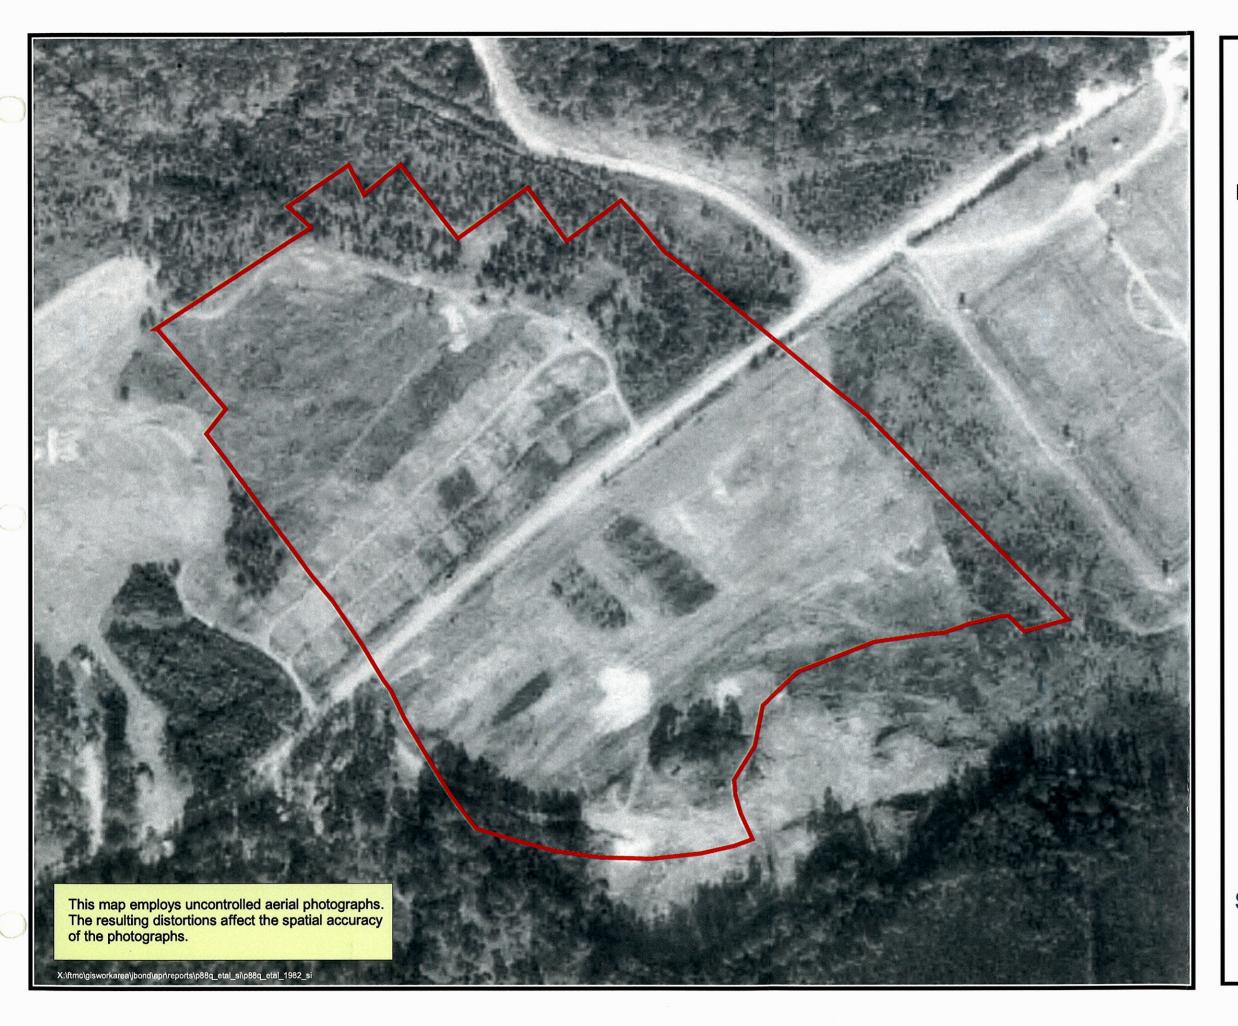
# Figure 1-7

- 8 **1982.** The 1982 aerial photograph (Figure 1-7) shows an additional berm and dirt road
- 9 constructed north of Falcon Road. Four new disturbed areas are also observed on this
- photograph. The berm extends southwest to northeast across the center portion of the area of
- investigation. The road on this photograph extends across the northern and eastern portions of
- the area of investigation. Much of the disturbed areas are found along the newly identified road.
- 13 A kidney-shaped cleared area can be found in the south-central portion of the area of
- investigation.
